Field Inspection Report
Murphy Candler park Bridge
Date: Dec. 30, 2015

Date of Inspection:	Dec. 18, 2015
Weather:	Clear sky, Temperature around 65 F.
Items of Inspection:	120' span pedestrian bridge

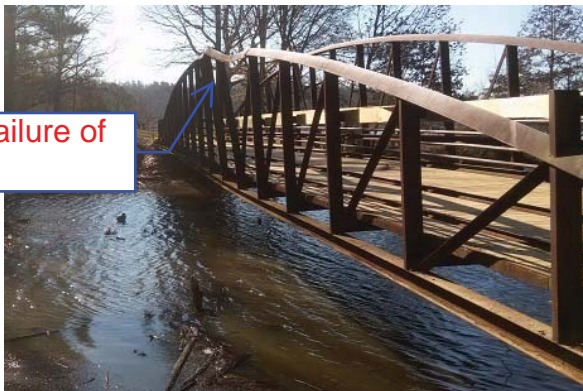
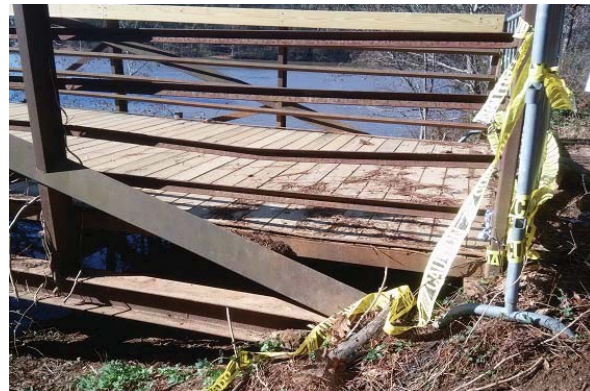
- 1) The curved steel angle on one side of the bridge had been badly damaged; this damage will create an unstable structure due to the buckling failure of top chord (curved steel angle). Please do not open this bridge to public; it is very unsafe.
